Conference Paper · March 2024

Transactions of the SMiRT 27
Yokohama, Japan, March 3-8, 2024
Division V

FSI IMPACT INVESTIGATION OF STEAM LINE BRANCH HANGER FAILURE

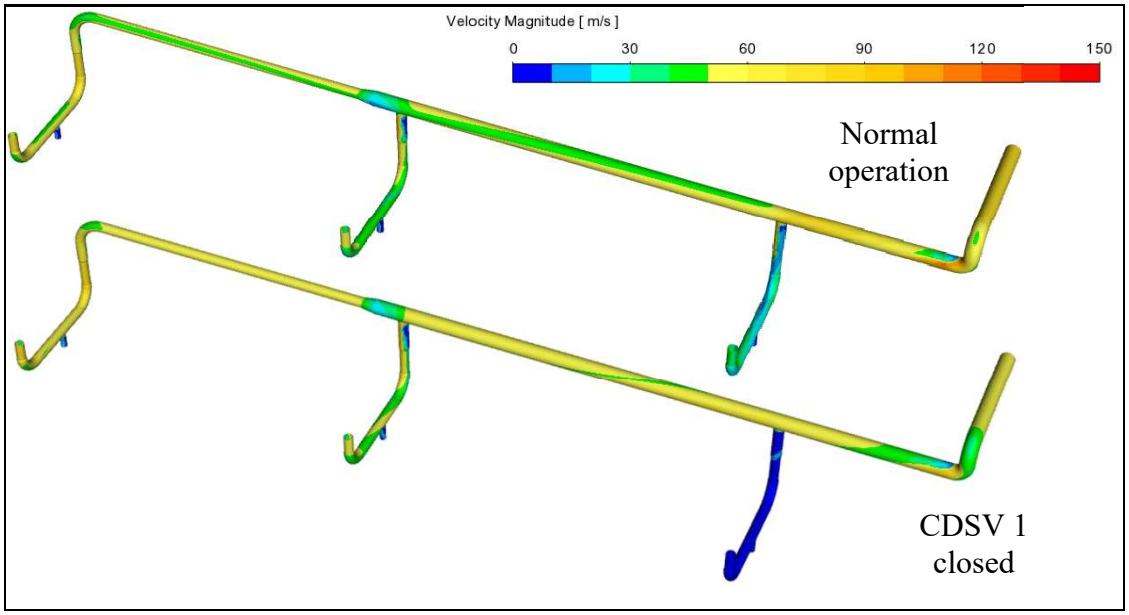
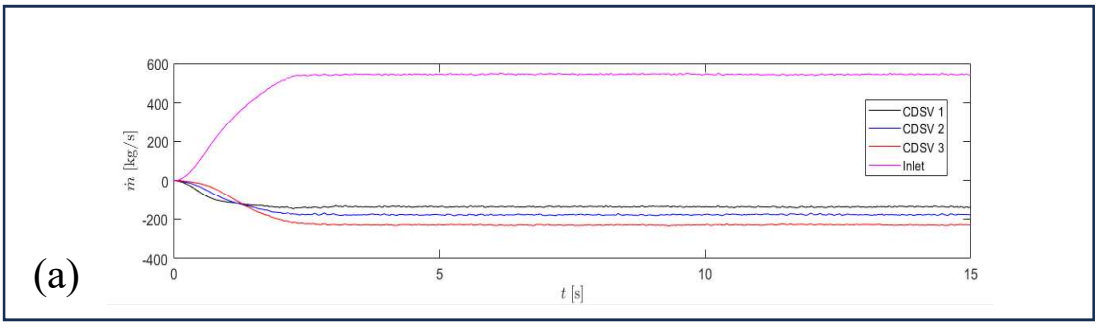
Figure 3. Contours of steady-state flow velocity magnitude at 10 cm from the pipe wall

The first 90-degree elbow upstream from CDSV1 has significant circulation due to the change in direction, and the maximum velocity is observed at the inner corner of the elbow. Notably, the closed branch in each leg had recirculating flow contributing to the pressure losses. The closure of one valve resulted in a reduction of the flow rate by 21% on average.

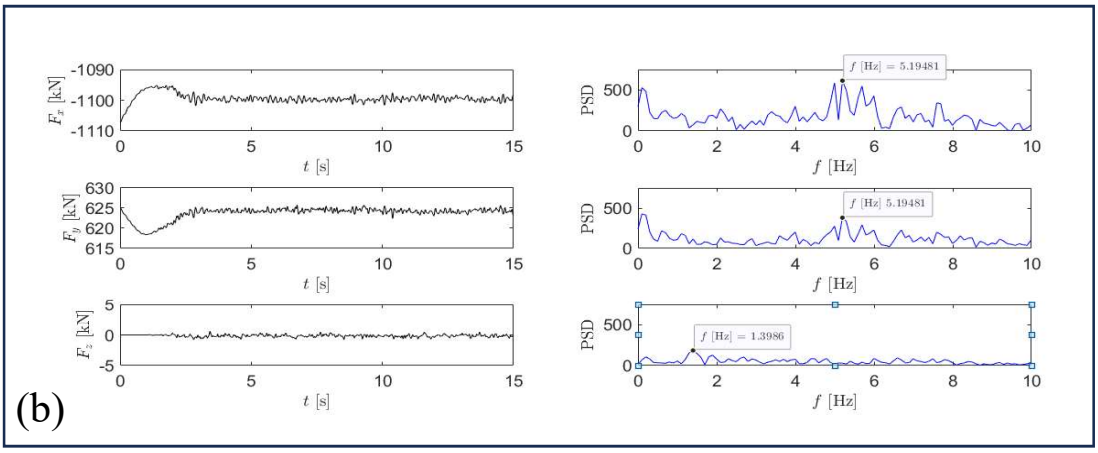
Figure 4. (a) The mass flow rate at boundary when all valves open within 2 seconds, and (b) Time development and spectral characteristics of force components on the piping segment

Figures 4a and 4b show the time development and spectral characteristics of the fluid force on the piping walls in the affected piping segment. The forces in *x* and *y* are not symmetric with the axis of the pipe segment, and thus include a significant pressure component. The z force is symmetric around the axis of the pipe and thus is caused by the shear force and asymmetric fluctuations of the pressure. During the first phase, the valves open in two seconds, causing a gradual change in the force according to the balance of the pressures. As the valves stay open, the fluctuations in the force induced by the turbulent flow are expected to be broadband. In addition, a fluctuating tonal force is observed at 5.2 Hz, which is expected to be related to the branch acoustic excitation by the grazing flow over the cavity mouth.

For the case where CDSV 1 remained closed, results showed that the tonal frequency became concentrated in the x direction and the peak slightly shifted to 5.9 Hz due to the change in the acoustic characteristic of the closed branch.

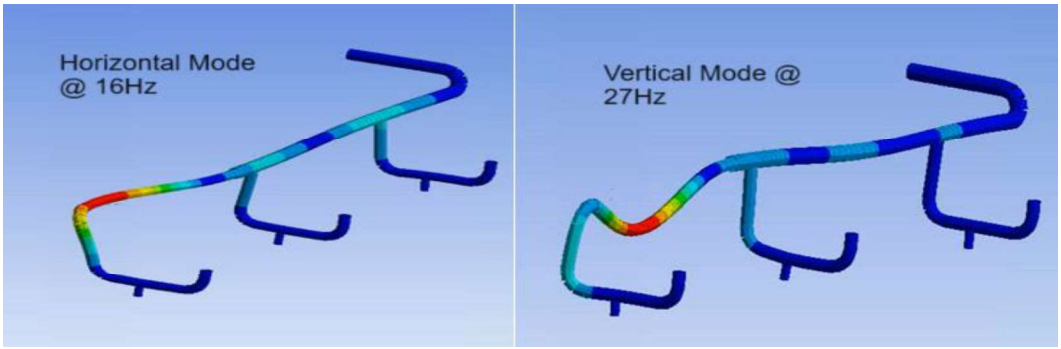
Figure 5. The two dominant local modes of piping vibration

The piping modes of vibration in the area of interest, that is, the failed hanger location, are shown in Figure 5. The local horizontal mode vibration frequency is at 16 Hz and the local vertical mode vibration frequency is 27 Hz. As shown in Figure 4b, the dominant frequency of the fluid pressure pulsation forces is roughly 5.9 Hz, so there seems to be no excessive vibrations in the piping response caused by the flow induced pressure pulsations.

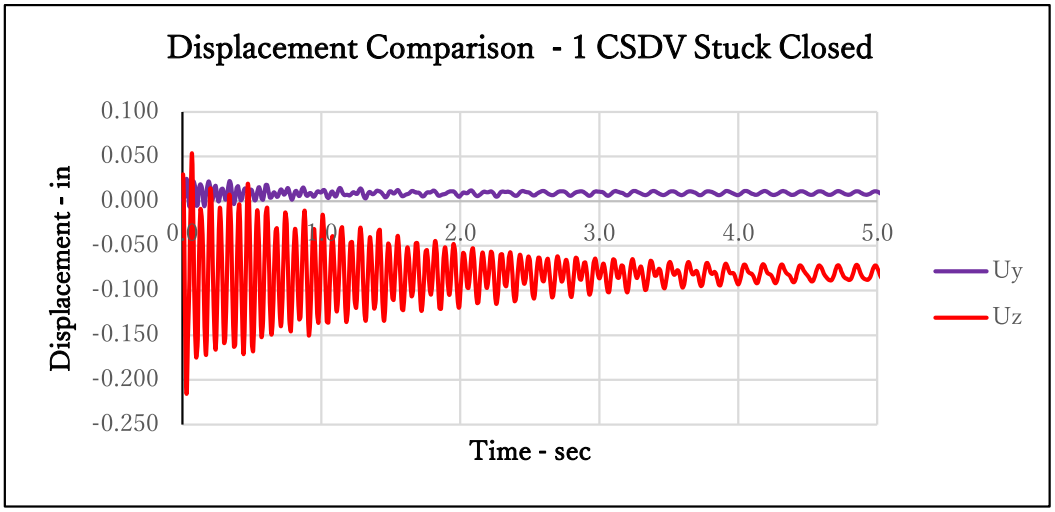
Figure 6. Vertical & Horizontal displacements comparison

The displacement response for normal steam reject line operation, i.e., three CSDVs open, was similar to the abnormal operation where one CSDV is stuck closed and only two only two valves are open. The results for the abnormal operation were slightly higher so they are reported in Figure 6. For better visualization of results, only 5 seconds data is plotted in Figure 6. It can be seen that vertical response is much smaller than the horizontal response. The low vertical response is due the fact that piping is well supported vertically in the vicinity of the failed hanger. During the first 2 seconds of CSDVs operation (time for CSDVs to fully open), there is rather strong vibration in the horizontal direction with a maximum range of 0.27" peak to peak. It can be seen that piping response becomes rather constant (range roughly 0.004") near 5 seconds.

- During the two seconds taken by CSDVs to fully open, transient vibration takes place in the section of steam reject system near the failed hanger location. The transient vibration is more in magnitude in the horizontal direction than in the vertical direction. The maximum range of peak-to-peak vibration amplitude is nearly 0.27".

- The vibration amplitudes decrease beyond the first two seconds (full opening of CSDVs) and a steady state is reached afterwards with an amplitude range of 0.004".

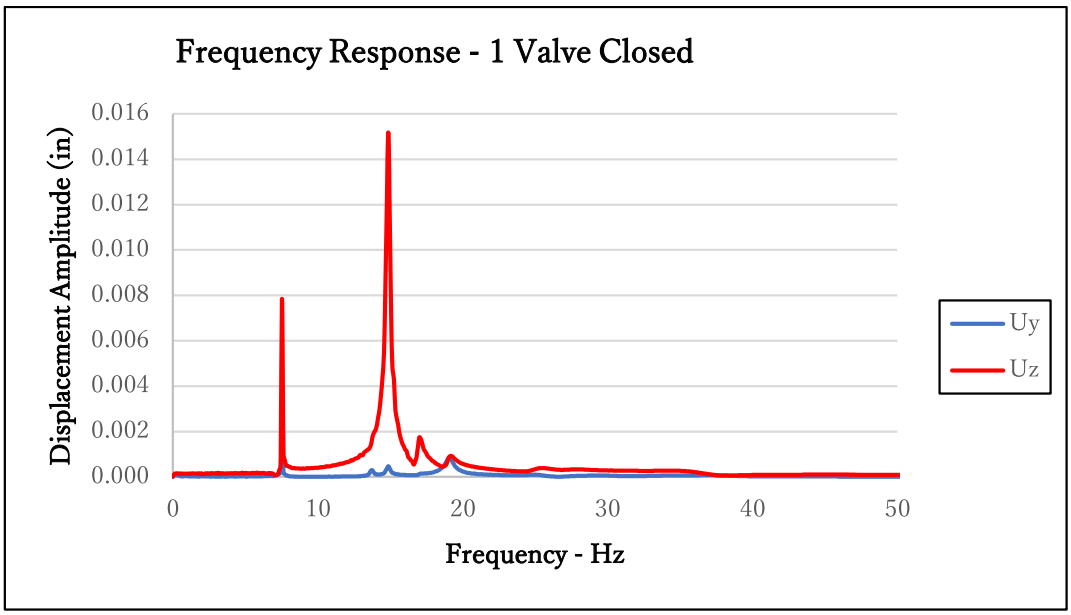
Figure 7. Frequency response, 1 CSDV stuck closed

The displacement time histories are converted into frequency domain using Microsoft Excel software. The frequency domain results are shown in Figure 7 below. The vertical displacement (Uy) has very, very small peaks at 8 Hz, and 19 Hz. But the horizontal displacement (Uz) has 2 rather large peaks at 8 Hz and 15 Hz. The corresponding amplitudes in horizontal direction are 0.008" and 0.015" respectively. The steam reject system continued operation past the initial 2 seconds operation also induces low amplitude high cycle vibrations in the steady state phase of its operation.

- The Fourier transforms of the steam reject piping displacements, in the vicinity of the failed hanger, yield couple of distinct frequencies of 8 Hz and 15 Hz for the horizontal displacement direction (Uz). The associated amplitudes are 0.008" and 0.015" respectively.

- It is judged from the results that the hanger failure probably results from a combination of small structural excitation and vibration fatigue resulting from low amplitude high cycle piping oscillations during repeated calls to operate the steam reject system.
